INTERSTATE COMMERCE COMMISSION

REPORT NO. 3543

THE PENNSYLVANIA RAILROAD COMPANY

Accident at Philadelphia, Pa., on November 11, 1953, caused by failure to operate a train in accordance with a signal indication when the route for the train was being lined, resulting in movement of a power-operated switch under the train.

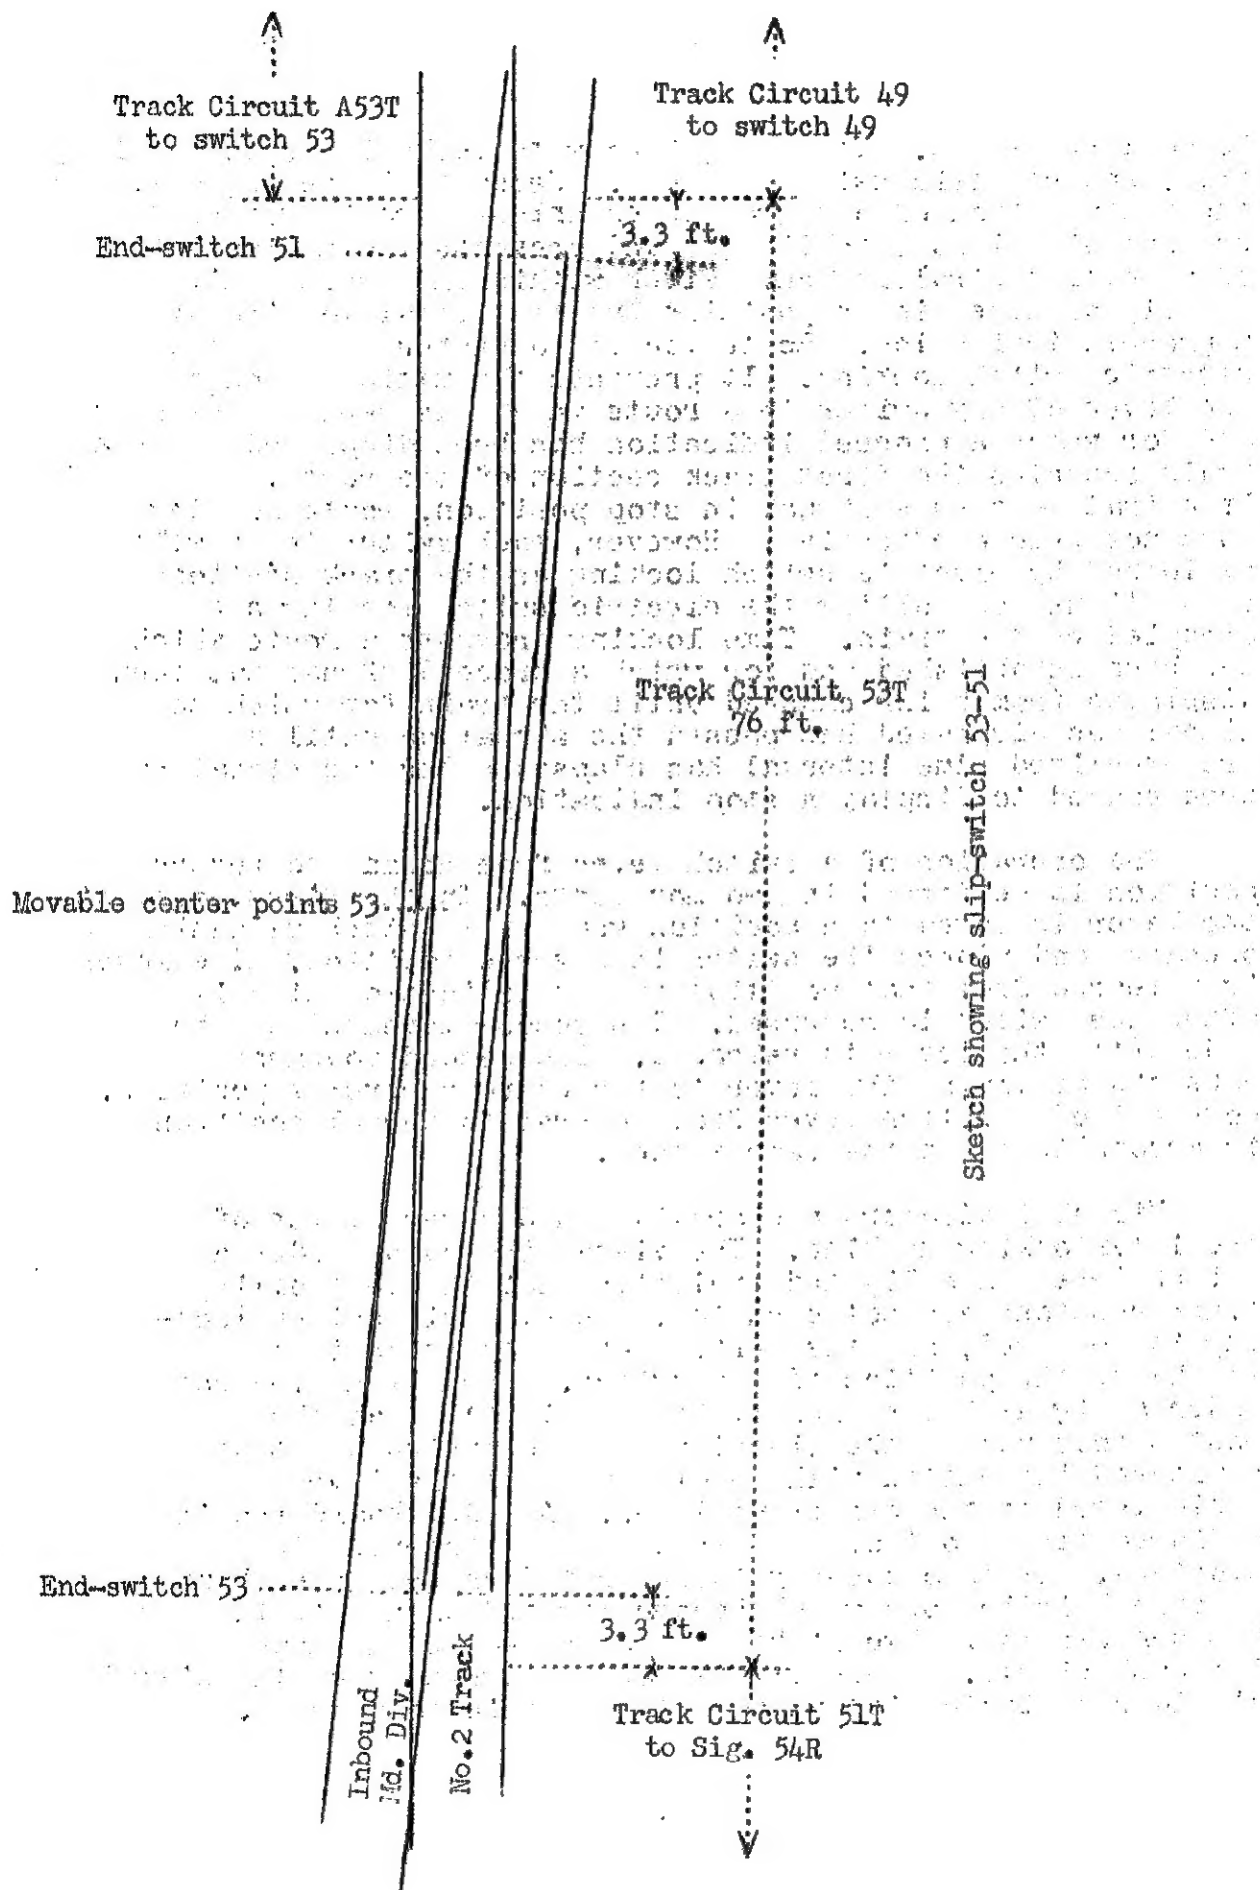
Lever 53 controls the operation of end-switch 53, the movable center points of slip switch 53-51, and switch 53. Levers 49 and 51 control the operation of switch 49 and end-switch 51. Track circuit 51T, controlling the electric switch locking of lever 51, extends between a point approximately opposite signal 54R and a point 3.3 feet west of end-switch 53. Track circuit 53T, controlling the electric switch locking of levers 51 and 53, extends 76 feet east of the east end of circuit 51T through slip switch 53-51. Track circuit 49 extends eastward from the east end of circuit 53T through switch 49, and track circuit A53T extends eastward from the east end of circuit 53T through switch 53.

After the accident occurred it was found that lever 54 was in position for signal 54R to display a stop indication, levers 49 and 53 were in normal position, and lever 51 was in reverse position. When lever 53 is in normal position end-switch 53 is lined for movement from track No. 2 to track No. 1. Examination of the track structure disclosed that the positions of the switches corresponded to the positions of the levers. No marks were found to indicate that any of the equipment was derailed at the slip switch. The first marks of derailment were found in the vicinity of switches 49 and 53.

In normal operation the train involved would remain at the station platform until the route was lined and an indication to proceed was displayed by signal 54R. Then when the train proceeded past the signal the switches would be electrically locked, which would prevent a switch from being moved under a train. From the manner in which the accident occurred it is clearly established that end-switch 53 was

moved after the front truck of the first car passed over it. Electric switch locking is ineffective for lever 53 if a train passes signal 54R when that signal indicates Stop and when lever 53 is not in extreme normal or reverse position. As a result of this investigation it is apparent that signal 54R indicated Stop when No. 809 passed that signal; that before No. 809 occupied track circuit 53T, the leverman, who was engaged in lining the route, moved lever 53 to the position where the switches controlled by that lever were in reverse position but electric switch locking was not effective; and that he returned the lever to normal position after the wheels of the first truck of the first car of No. 809 passed end-switch 53.
